GOWANUS CANAL

COMMUNITY ADVISORY GROUP (CAG)

RE: CAG Comments on the Gowanus Canal Natural Resources Damage Assessment Plan, 3/1/2024

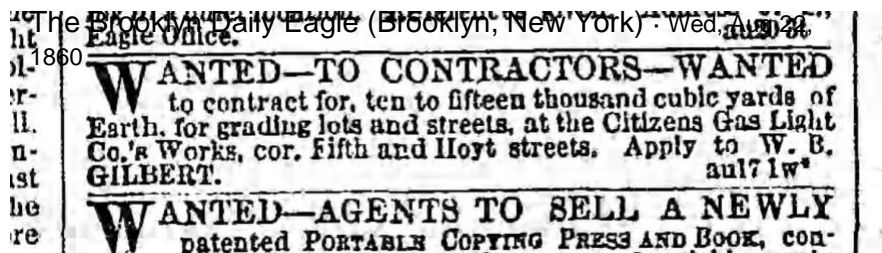
- any industrialization resulting in pollution of nearby areas like the uplands, the lower part of the harbor, bay, and area around Governor’s Island contribute to ongoing contamination of the Canal and should be considered in Canal remediation;
- Citizens Gas Works altered the grade and filled in the Gowanus at Fifth and Hoyt Streets, as evidenced in the below:

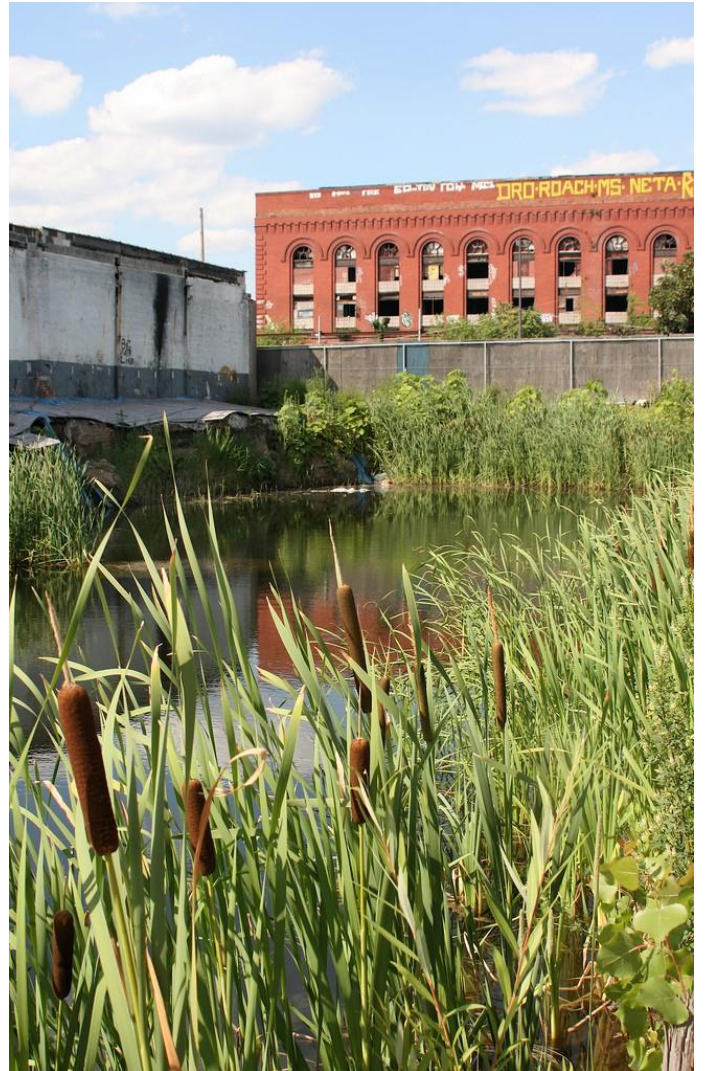
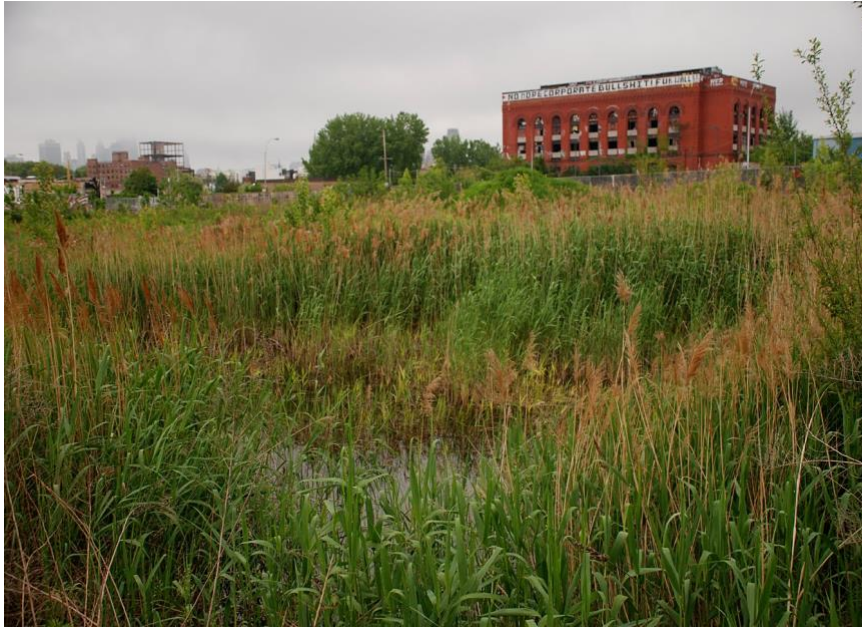
2007 July 10 - Gowanus Canal Whole Foods site (3rd Avenue & 3rd Street) freshwater wetlands emerging from historic Dentons' pond when toxic soil was removed - photo by Robert Gusskind

2009 - Gowanus Dentons Pond self healing - Whole Foods site during restoration with Paulownia (Empress tree), and bullrush - photo by Clayton Price

2009 - Whole Foods Site / Coignet Building area at 3 Av & 3 St - Wetlands growing in NYSDEC Brownfields / Dentons Ghost Pond excavation - photo by Nathan Kensinger

- Photos provided below showing the Gowanus Whole Foods site prior to its being built demonstrates how wetlands in the area are highly viable, given that wetland grasses sprouted throughout the area following the removal of septic-tanks from the site under the Brownfield program. The new wetlands created before development provided a habitat to nesting shorebirds and water birds.

GOWANUS WETLANDS: Some photos of the urban adapted species that automatically came back during the excavation of the contaminated soil at Whole Foods

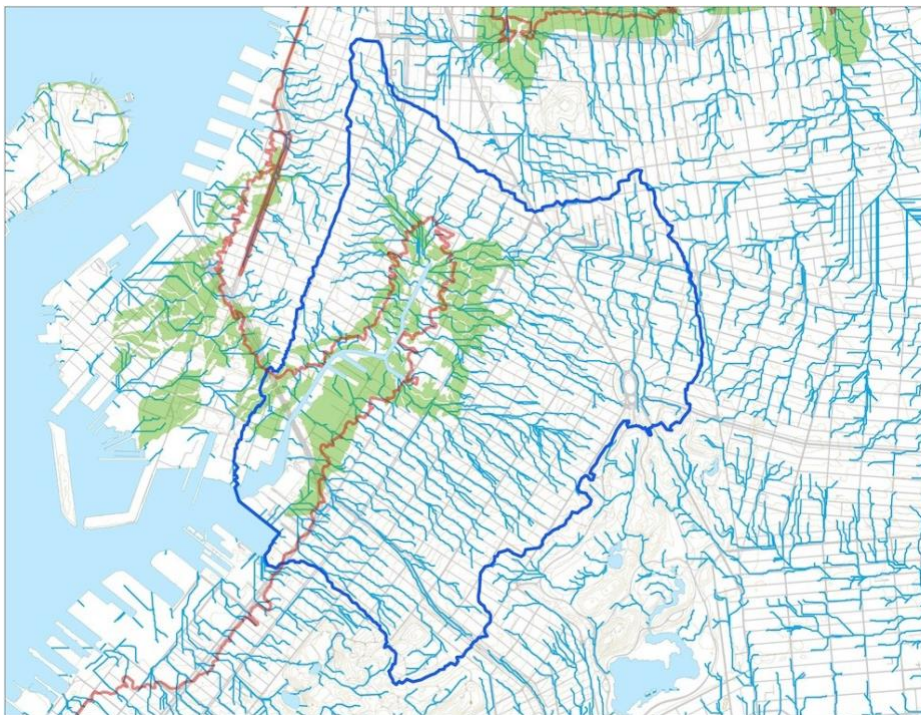
The blue watershed outline below is what should be used as the functional Gowanus Watershed NRDA restoration area

- Green shows the historical tidal wetland marsh (now buried).
- Red shows the Sandy storm surge flood limits. Obviously such a surge could reoccur. Consider the Sandy line as the functional Gowanus ecosystem flood zone.

- Thin blue lines represent storm water runoff that will eventually re-sediment the canal either through direct street runoff or through the combined sewer overflows.

A Canal only NRDA focus is unscientific and ecologically meaningless in terms of how the Gowanus ecosystem works.
